HMP Wandsworth Vaulted ceiling access scaffold case study

The London Division of VCUK were contracted to undertake a refurbishment of an existing Victorian accommodation block comprising of three wings springing from a central rotunda at HMP Wandsworth.

Part of the works required the London Division to undertake redecoration of the existing vaulted ceiling located over the atrium to each of the wings.

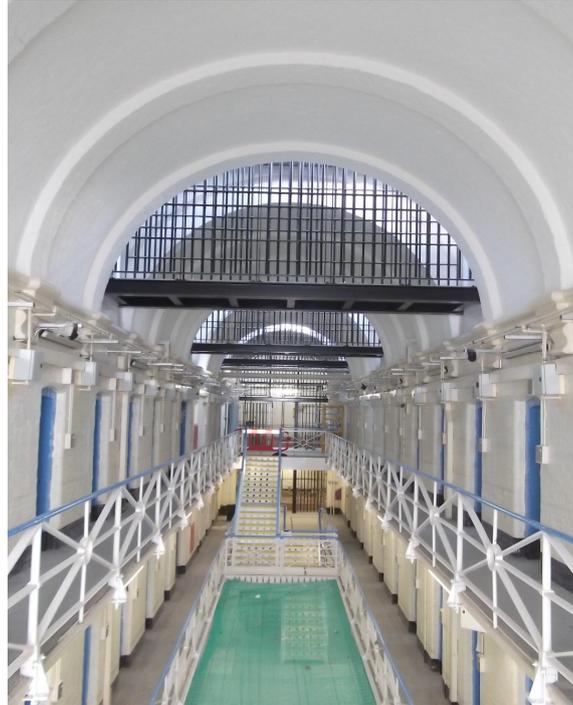
Photo 1: Atrium vaulted ceiling to one of the wings

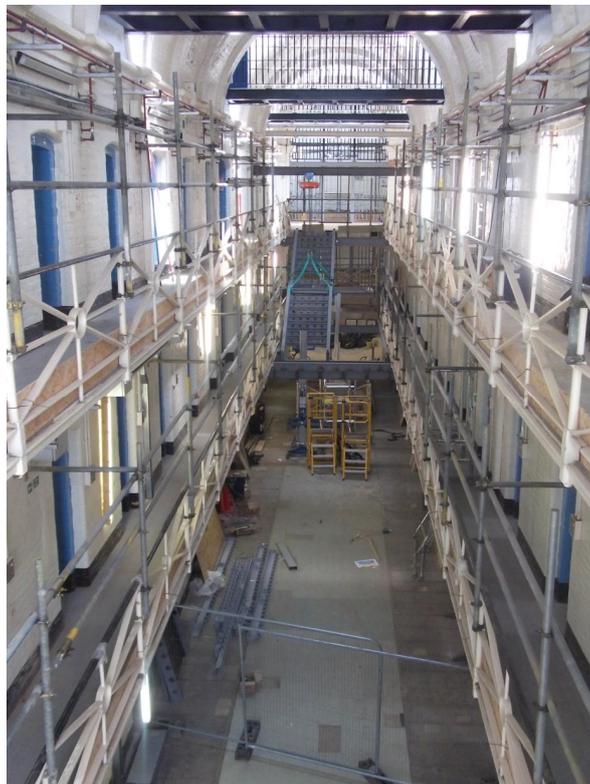
Photo 2: Atrium during the construction period

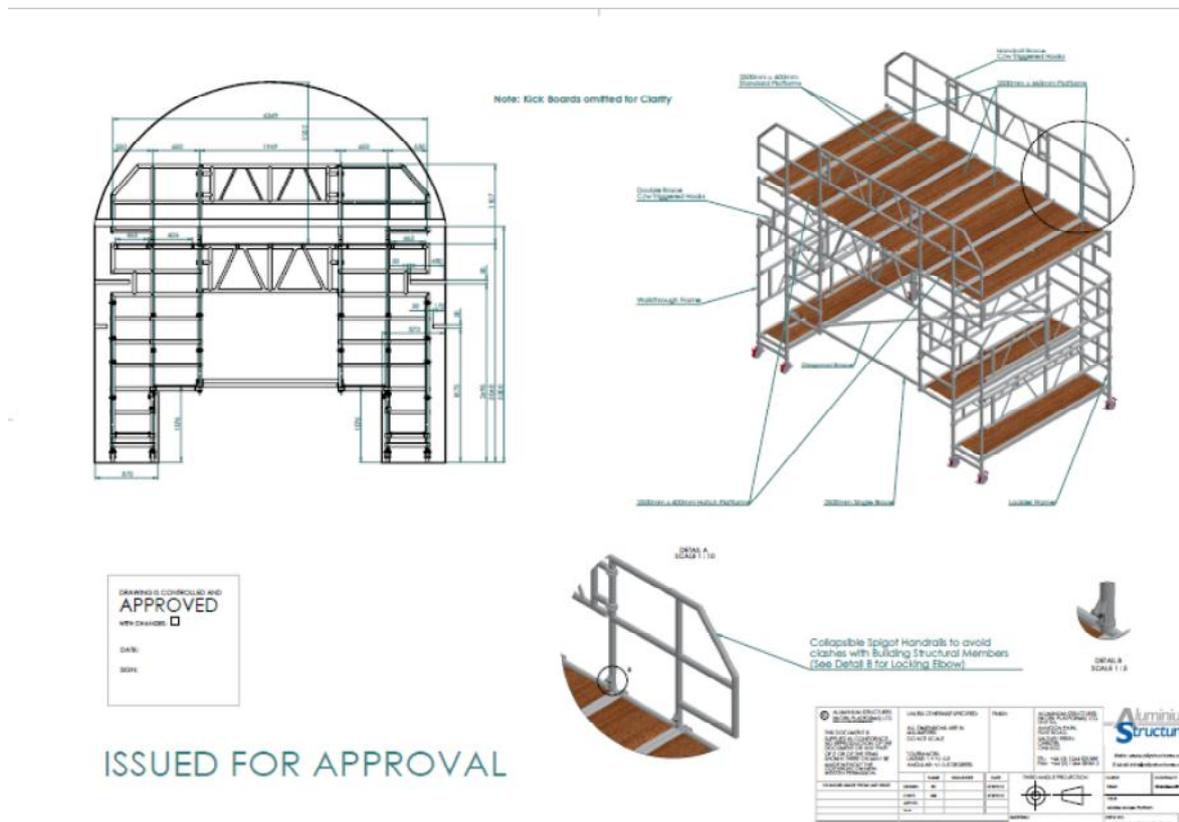
Drawing in figure 1 below details the final design of the scaffold which was signed off by site team and VCUK temporary works department.

Figure 1: Final Access system solution for accessing the vaulted ceilings.

The system was designed using lightweight aluminium tubing welded together to form demountable components which negated the need to have trained scaffolder's to erect and dismantle the system. The demountable sections also made it easy to manually transport the system to the required location without the risk of injury.

Castor wheels were placed on the outer legs of the access system with the inner leg being mounted on a 4m long rail which was used to avoid excessive point loading of the system on the cantilevered landings either side of the atrium. This allowed the system to be trolleyed along the landings from bay to bay without the need to dismantle it with the exception where it had to pass under the control and restraint bridges – shown in photo 1. The system design allowed the handrails to be removed independently to allow the tower to be trolleyed under the control and restraint bridges that bisected the vaulted ceiling at certain locations.

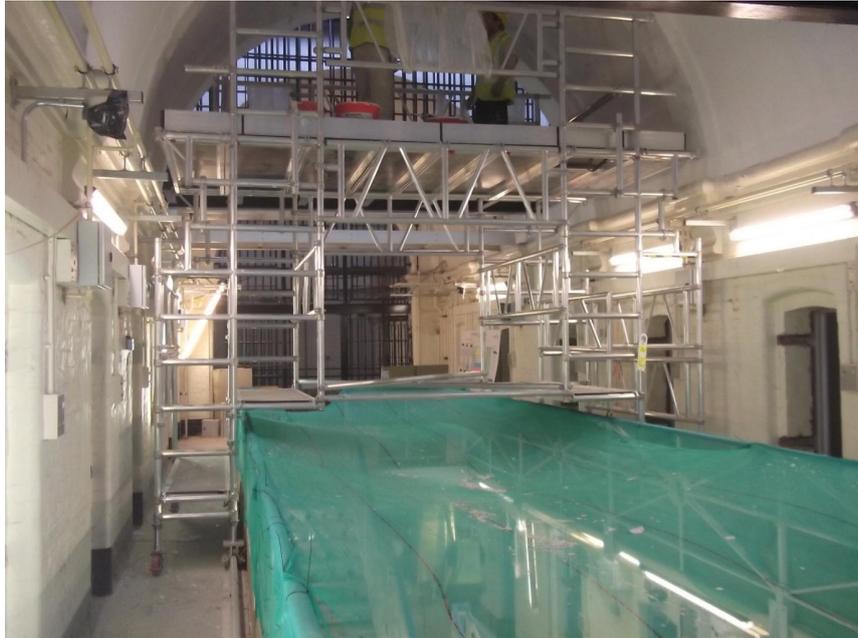
Photo 3: Vaulted access scaffold designed Aluminium structures (work platforms) Ltd in use on one of the wings

Note: the inside leg of the scaffold tower landed on a 4m long rail which helped to spread the load of the system along the walkways.

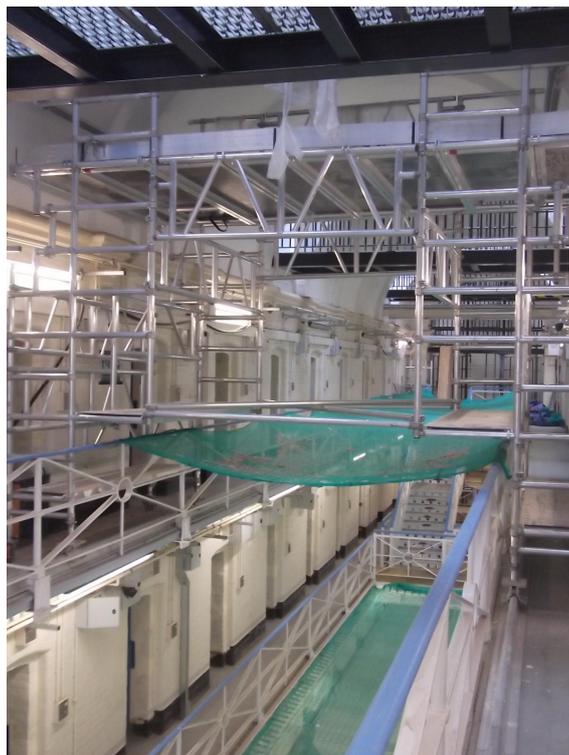
Photo 4: Vaulted access scaffold shown spanning the atrium from the underside.
